# Manhole Inspection Summary

Manhole # S15YY1004MH

Insp Date: **4/19/07 10:05 AM**

**Location** Address: **2025 ROGERS AVE**

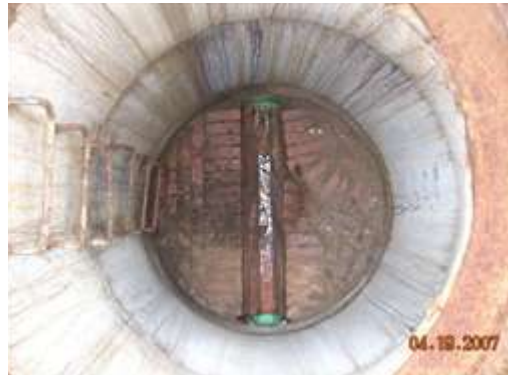
Top View

**Bench** ☒ Exists Material: **Brick** ☐ Parged ☒ **Debris** (not Condition related)

**Steps** Count: **6** Missing: **0** ☒ **Corroded**

Bench debris. Corroded steps.

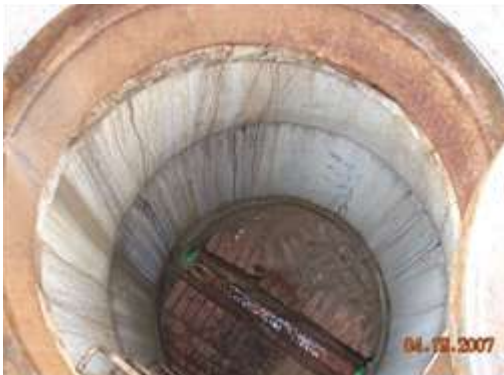
Defect

**Frame** Offset: **0** (in.) Condition: ☐ Sound ☐ Cracked ☒ **Leaks**

Condition: ☐ Sound ☐ Cracked ☐ Root Intrusion ☐ Loose Brick ☒ **Deteriorated**

Infiltration: ☐ None ☒ **Joint** ☐ Cracks ☐ Mortar ☐ Roots ☐ Wall

Frame leaks. Adjustment deterioration and infiltration - other side.

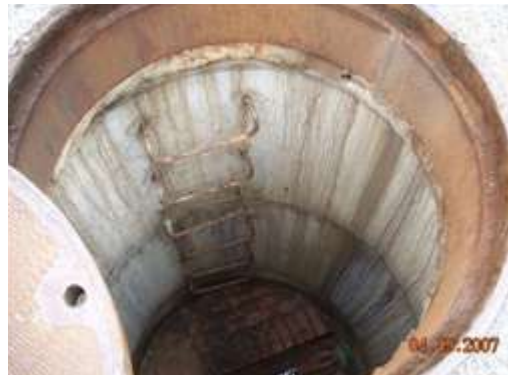
Defect

Frame leaks. Adjustment deterioration and infiltration.

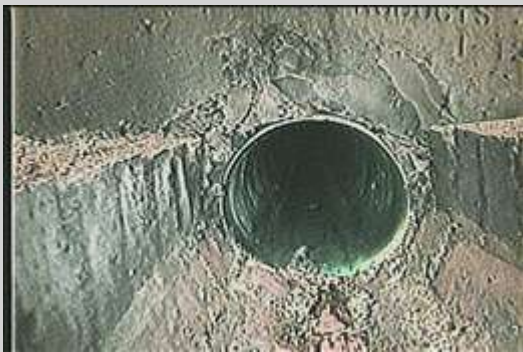
Pipe Out @ 12 O'Clock

Infiltration: **None**

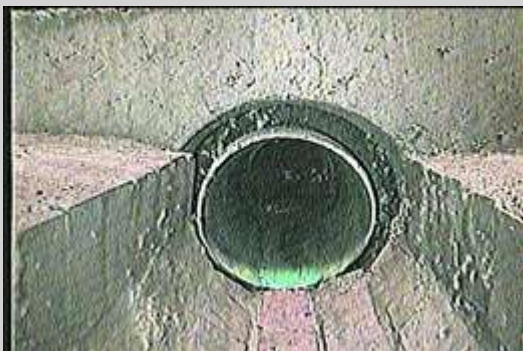
Pipe In @ 6 O'Clock

Infiltration: **Evidence**
